CENTERVILLE BEACH SPLIT
PIPE REPAIR

Ocean Engineering

CHESAPEAKE DIVISION
NAVAL FACILITIES ENGINEERING COMMAND
WASHINGTON NAVY YARD
WASHINGTON, DC 20374

1977

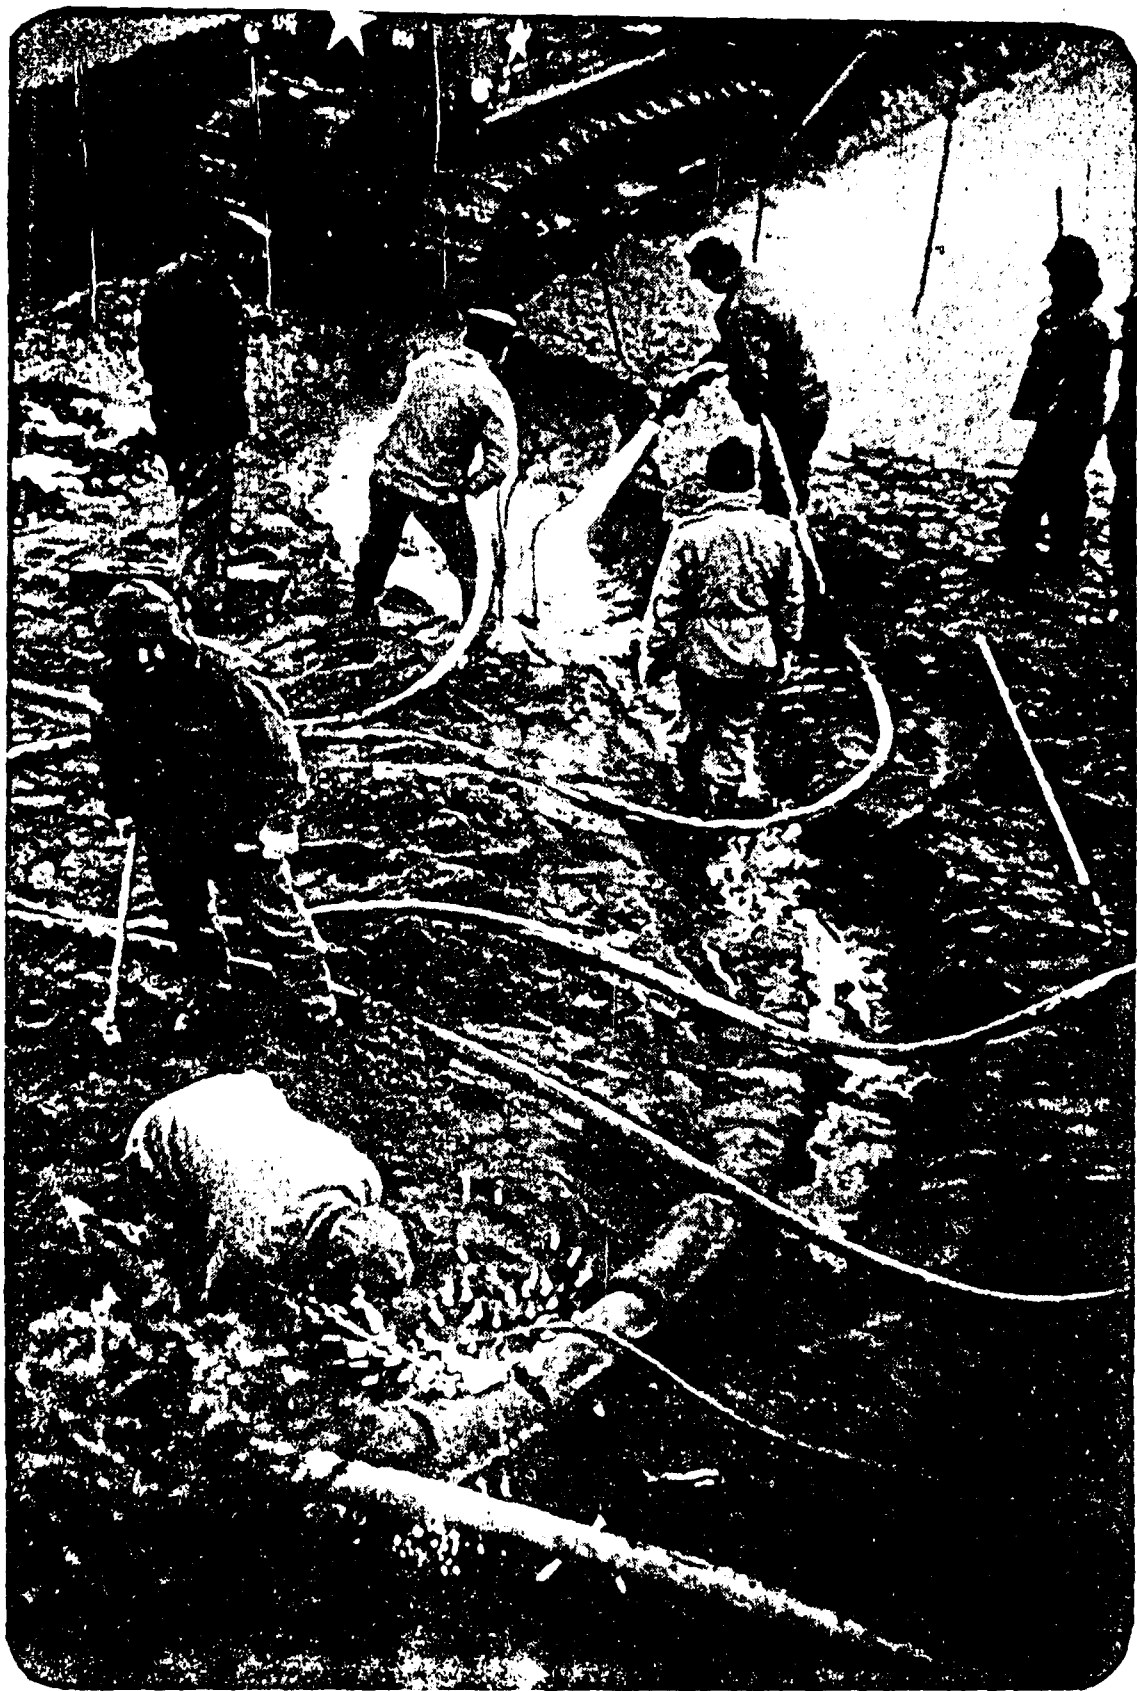
Men working on the cable.

(U) 2. Next, sections of the cable were lifted either by hand or with the backhoe while the wire mesh cage with the standoffs attached were fitted around the cable. The standoffs (rectangular plastic boxes) were stapled on the inside and outside circumference of the prefabricated steel cage in order to center the cable inside the cage and center the cage inside the nylon bag (Appendix B). Figure 9 shows the cable being lifted and the wire cage with standoffs being applied (note the taped section of cable). This phase of the operation took about 30 minutes per cable.
